**Risk Assessment of The Kingtom And Granville Brook Dumpsites In Freetown, Sierra Leone**

**Abstract**

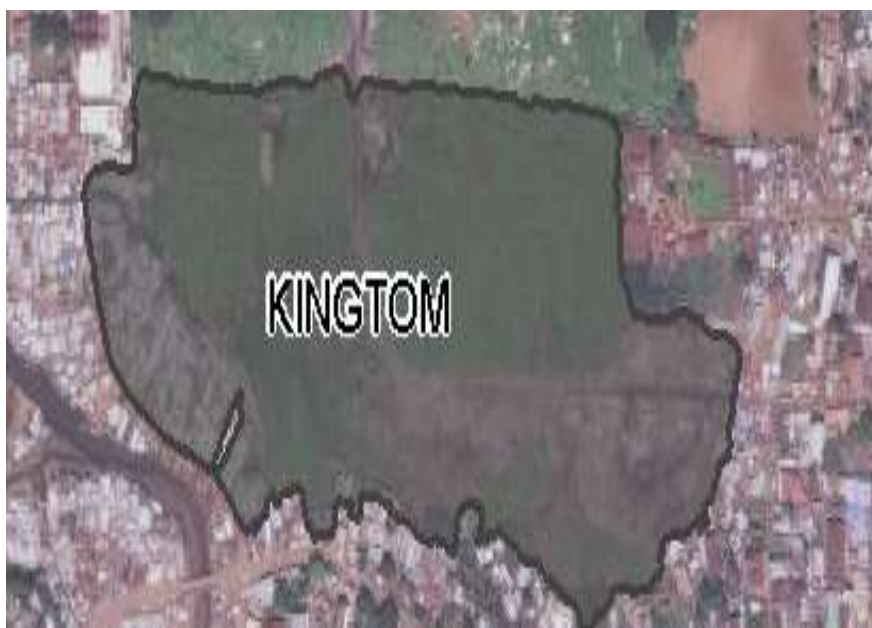
Figure 1: GIS image of the Kingtom dumpsite

The Kingtom dumpsite was established in the 1940s. It is situated in the west-central part of Freetown within an area of 14.544 Acres. The southern border is Ascension Town road. Kingtom Community lies to the north and to the west is bay. The Kingtom dumpsite serves the western and central sectors of Freetown. The site supports a growing and vibrant community engaged in scavenging of materials at the site and selling mangrove wood for cooking. The Kingtom Dump site is on the estuary of the Congo River where it empties to Man of War Bay which borders the Atlantic Ocean. The area is an integral part of an intertidal brackish water zone ecosystem containing almost exhausted mangrove vegetation.

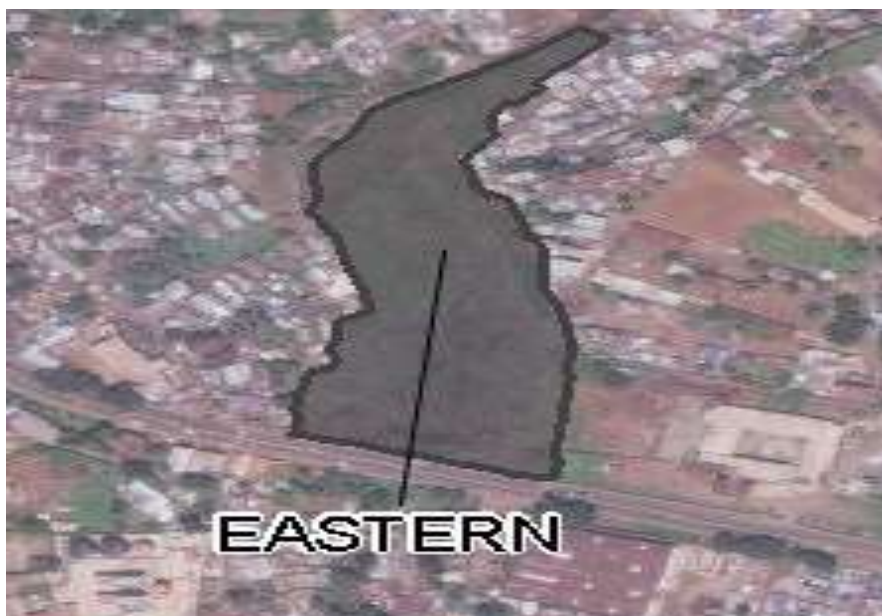
Figure 2: GIS image of the Eastern (Granville Brook) dumpsite along the Bai Bureh road

The Granville Brook dumpsite has been in operation since the late 1980s. It is located in a deep valley of the Granville Brook River along the Bai Bureh road within residential area and its surroundings are fully urbanized communities. The dumpsite covers an area of 14.968 Acres. It serves the eastern sector of Freetown. The site is bordered to the east by the valley wall and to the south by the Waterloo Road (Figure 2). The west of the site is limited by the Granville Brook stream channel and is open ended to the north where the Granville Brook joins the Sierra Leone River.
